**WANGAUM FALLS DAM**

Number  
NDI NO. PA-00141  
Number  
DER NO. 64-102

**PHASE I INSPECTION REPORT.**

**NATIONAL DAM INSPECTION PROGRAM.**

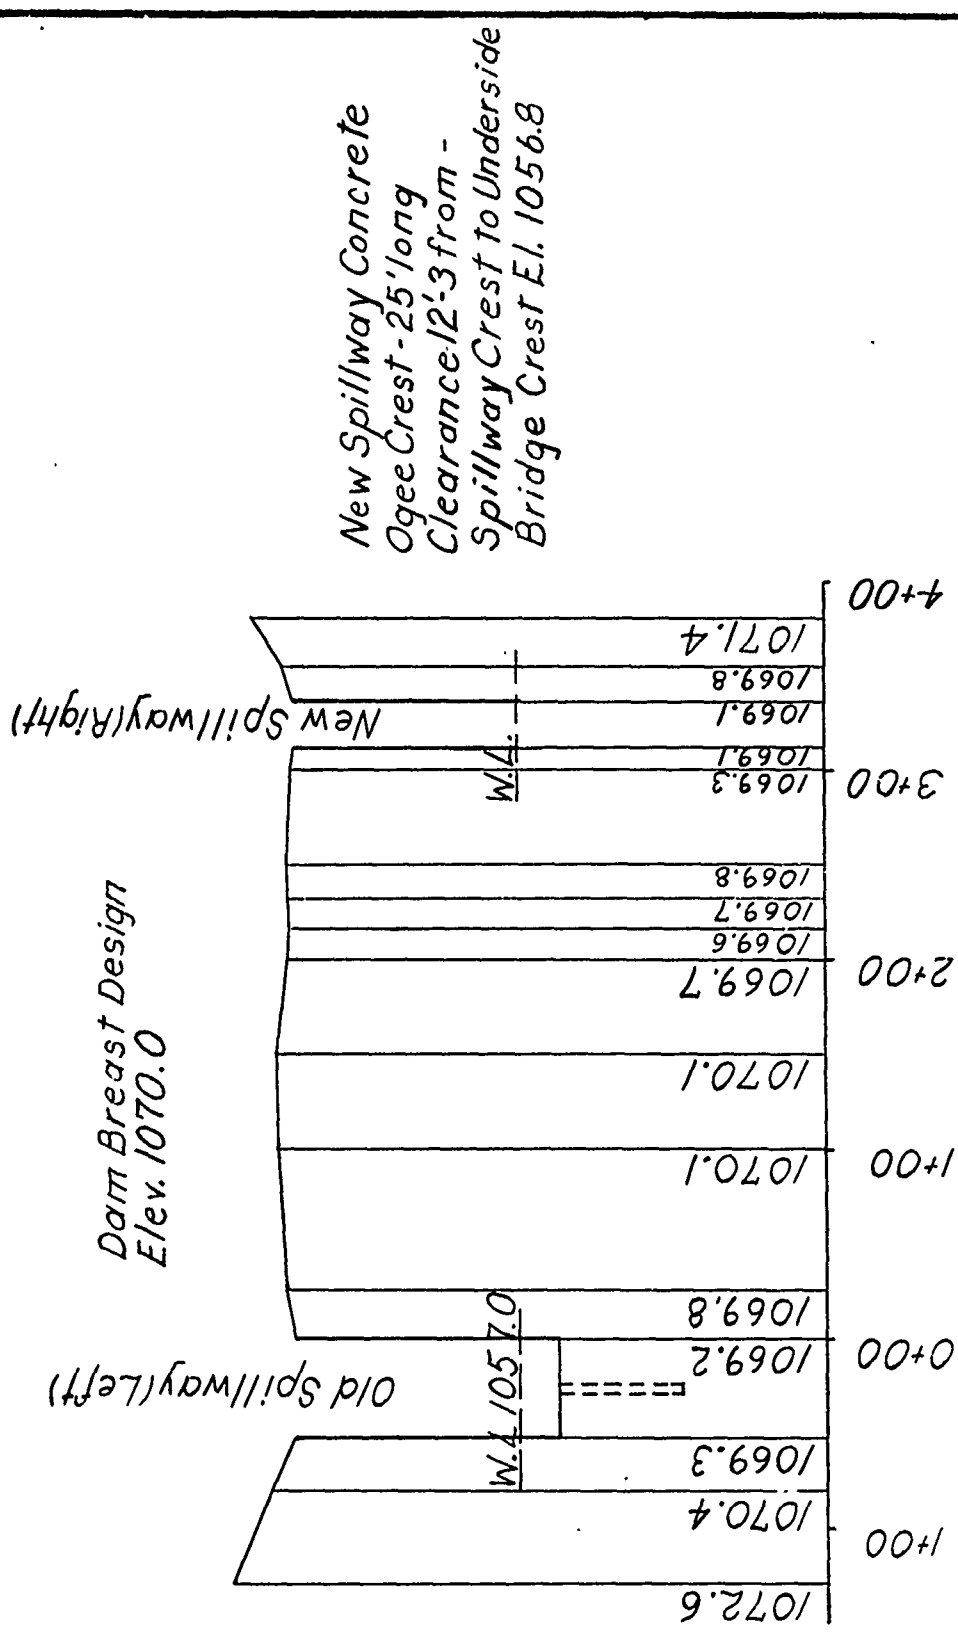
WANGAUM FALLS DAM  
PA.-00141  
INSPECTION SURVEY  
PLATE A-II

D. ALIGNMENT OF CREST: HORIZONTAL: VERTICAL:	Horizontal alignment - curve & tangent okay. Verticle - see profile Plate A-II.
E. RIPRAP FAILURES	Upstream slope of embankment covered with dumped rock with some short weed growth. One small evergreen tree. Rip rap is in stable condition.
